# Manhole Inspection Summary

## Manhole # S37GG\_032MH

**Location** Address: **1504 BRENTWOOD AVE**

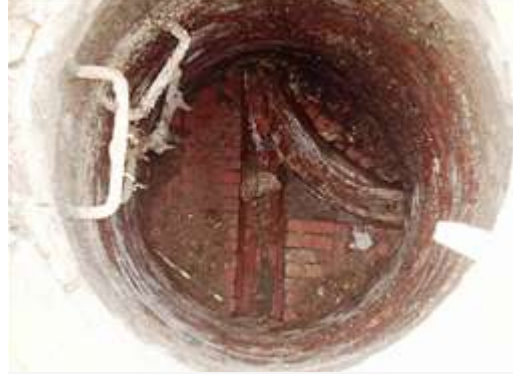
Top View

Evidence of surcharge - Bench debris.

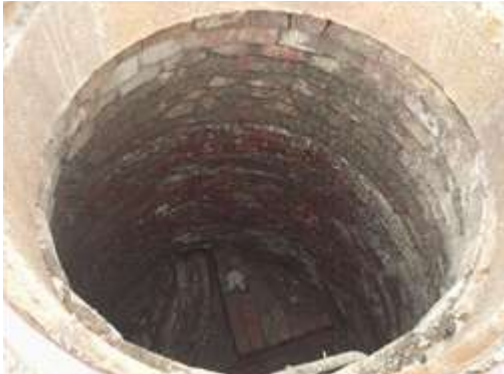
Defect

Cracked frame. Frame leaks. Frame offset. Adjustment deterioration and infiltration. Corbel infiltration - other side.

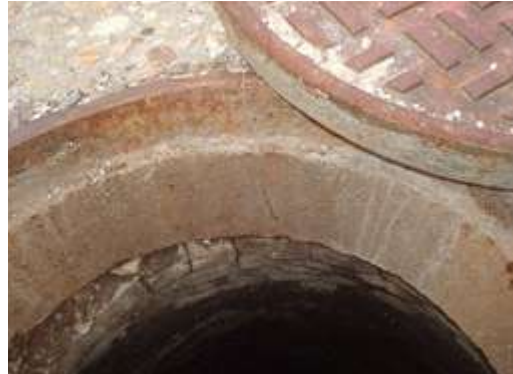
Defect

Cracked frame. Frame leaks. Frame offset. Adjustment deterioration and infiltration. Corbel infiltration.

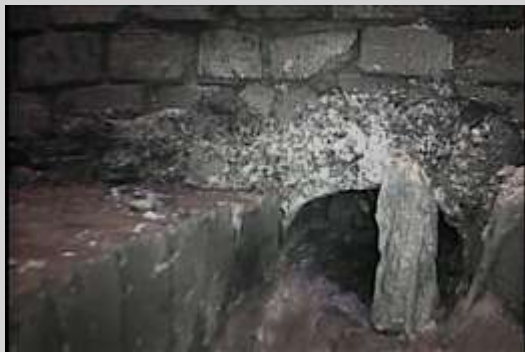
### 8 in. Circular Gravity Sewer Pipe Out @ 12 O'Clock

Barrel deterioration and infiltration. Channel deterioration.

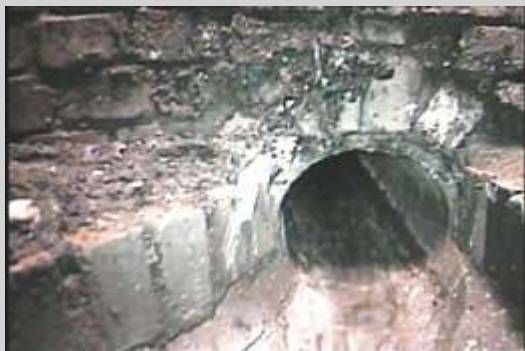
### 8 in. Circular Gravity Sewer Pipe In @ 3 O'Clock

Barrel deterioration and infiltration.

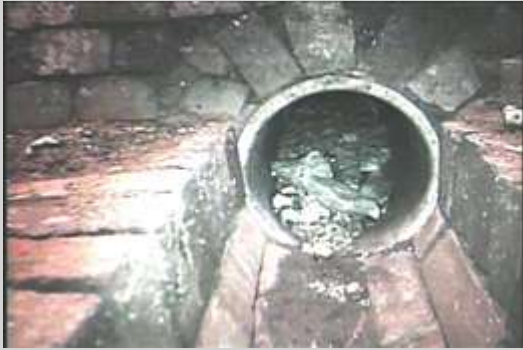
Pipe In @ 6 O'Clock

Barrel deterioration and infiltration. Channel deterioration.
